CONDITION SURVEY, LIBBY ARMY AIRFIELD FT. HUACHUCA, ARIZONA

April 1971

Conducted by U. S. Army Engineer Waterways Experiment Station, Vicksburg, Mississippi

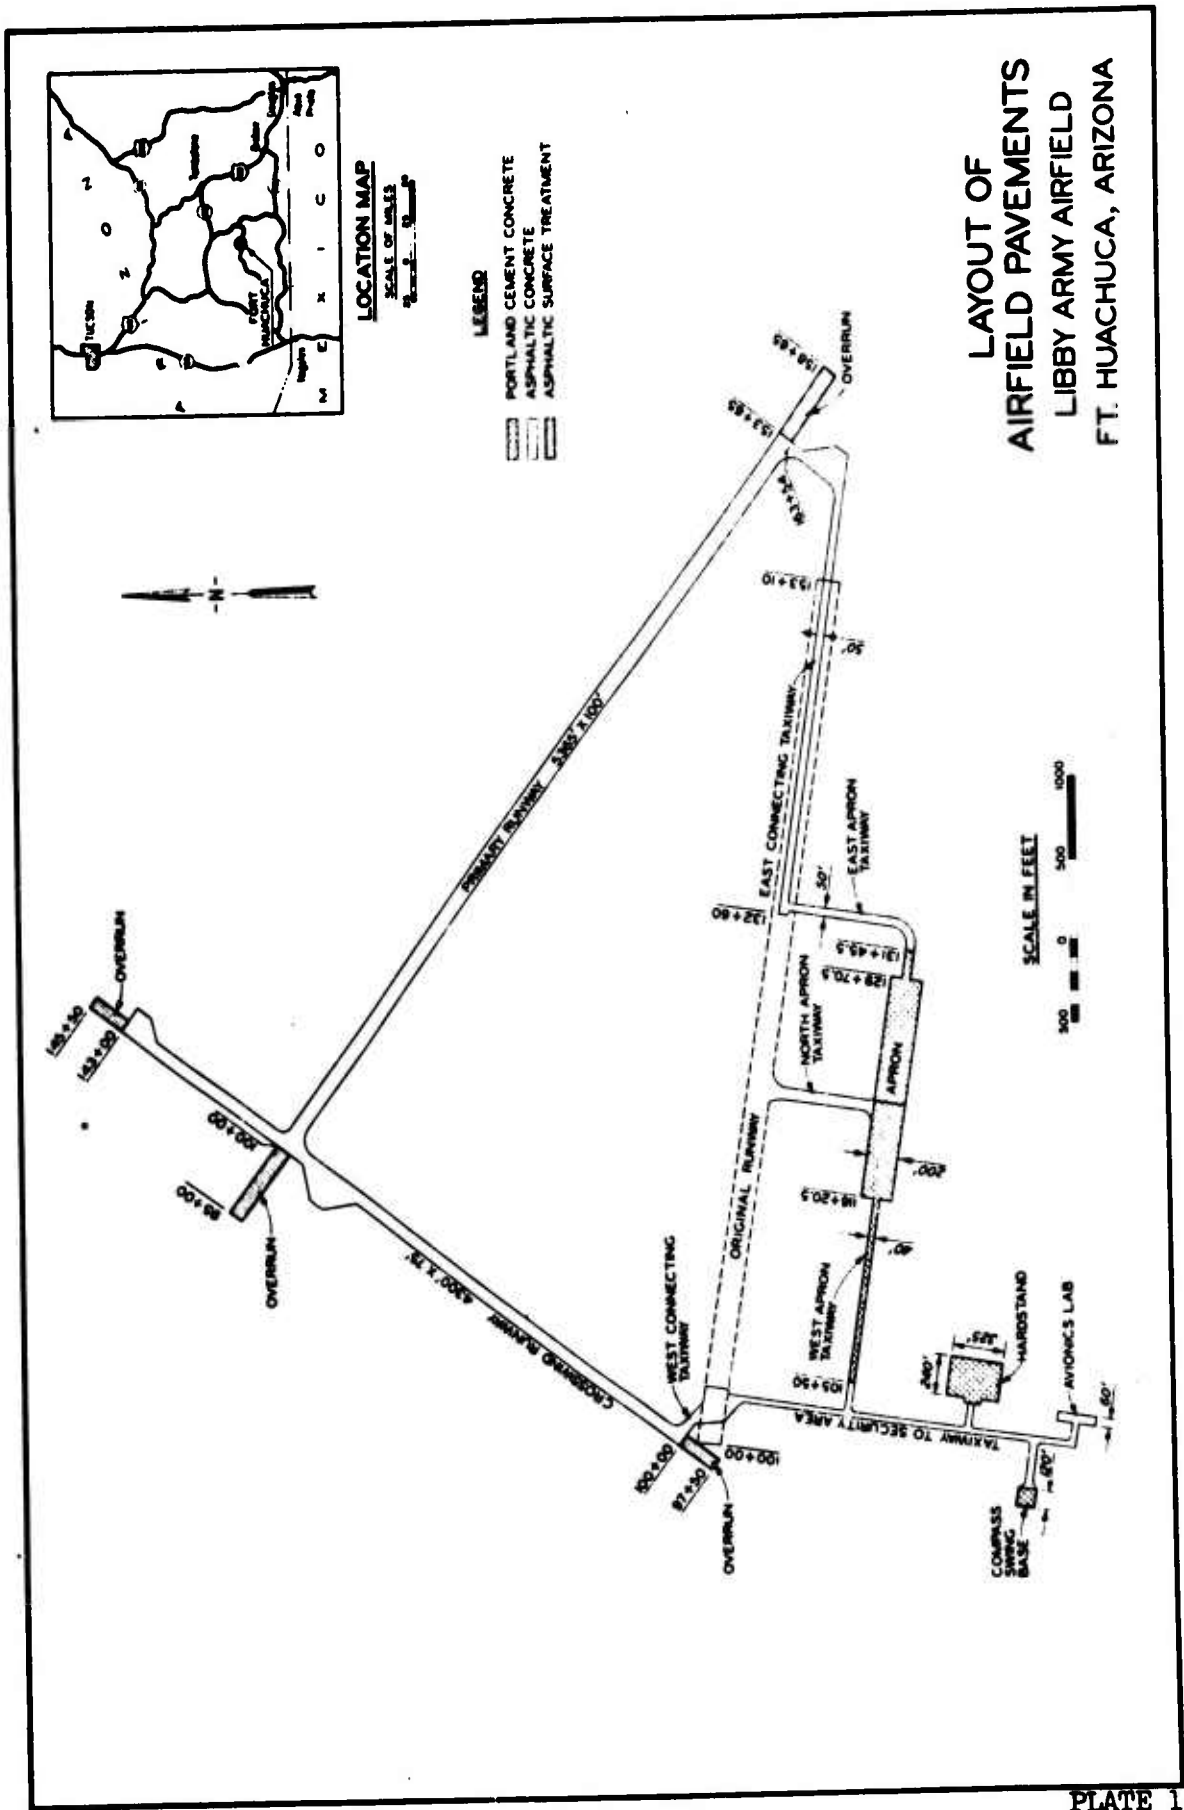
PLATE 1

1. The purpose of this report is to present the results of an investigation performed at Libby Army Airfield (LAAF) in September 1970. The inspection was limited to visual observations, and no tests were conducted on the existing runways and taxiways. A layout of the airfield is shown in plate 1.

the apron to the runways, and a connecting taxiway to the security area were constructed (as shown in plate 1). A portion of the east connecting taxiway to the primary runway utilized a 50-ft-wide area of the existing runway. The pavements were designed for a 22,000-lb load on a single-wheel gear with 100-psi tire pressure. Pavements consisted of both asphaltic concrete and portland cement concrete. A complete construction history is shown in table 1. A layout of the airfield pavements is shown in plate 1. Typical pavement sections are shown in plate 2.

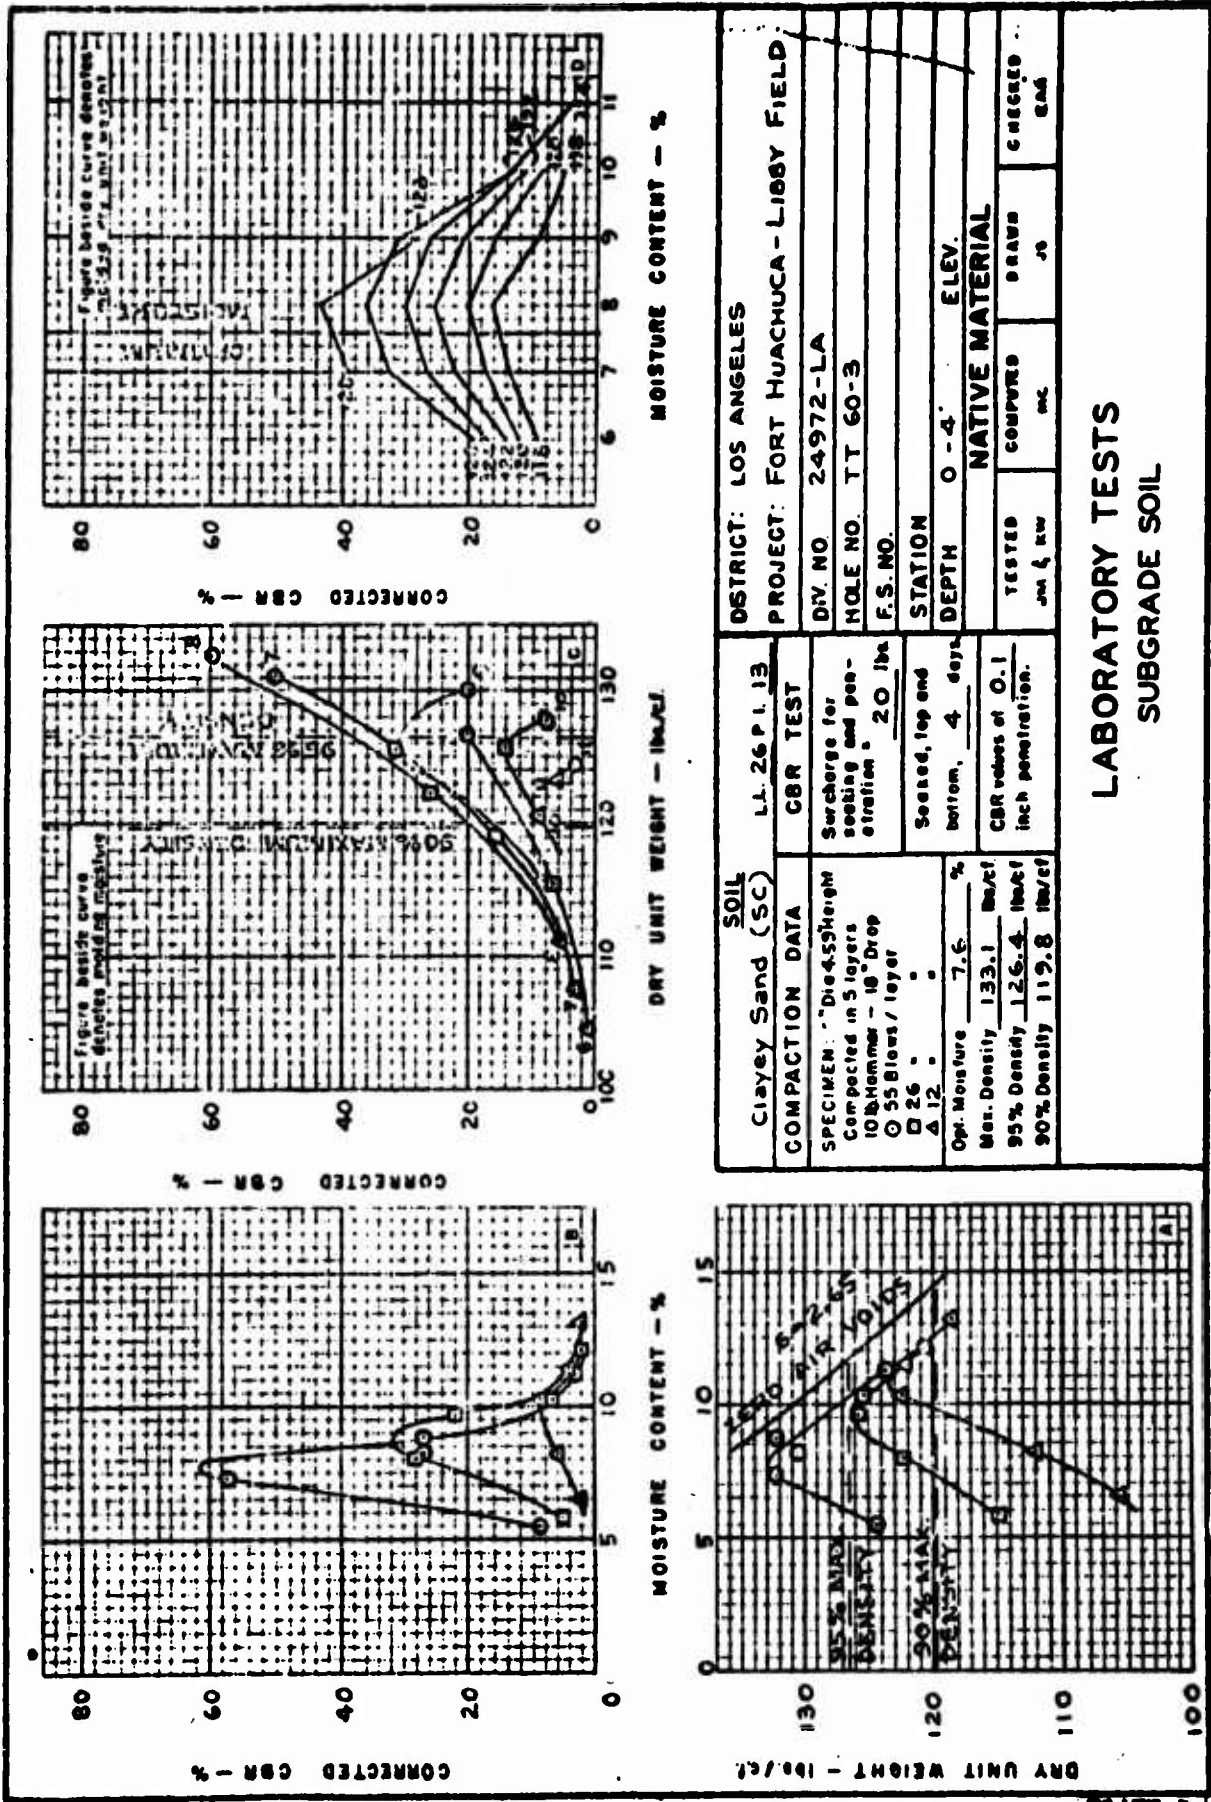
PLATE 5

16. The native subgrade soil classifies as a clayey sand (SC) having a plasticity index of about 13. Results of laboratory tests on the material are shown in plate 5. Previous tests for evaluation performed by the WES and reported in the reference listed in paragraph 4b assigned a CBR of 10 for the subgrade soils investigated. A CBR value of 8 was assigned the subgrade soils for design in the 1961 construction, and the value of 8 was also used for this evaluation.
